**GROUND MOVEMENT STUDY  
HAUSSLER ROAD AREA  
KELSO, WASHINGTON**

Environmental Geology, G561  
Portland State University  
Winter Term 1999

**Abstract**

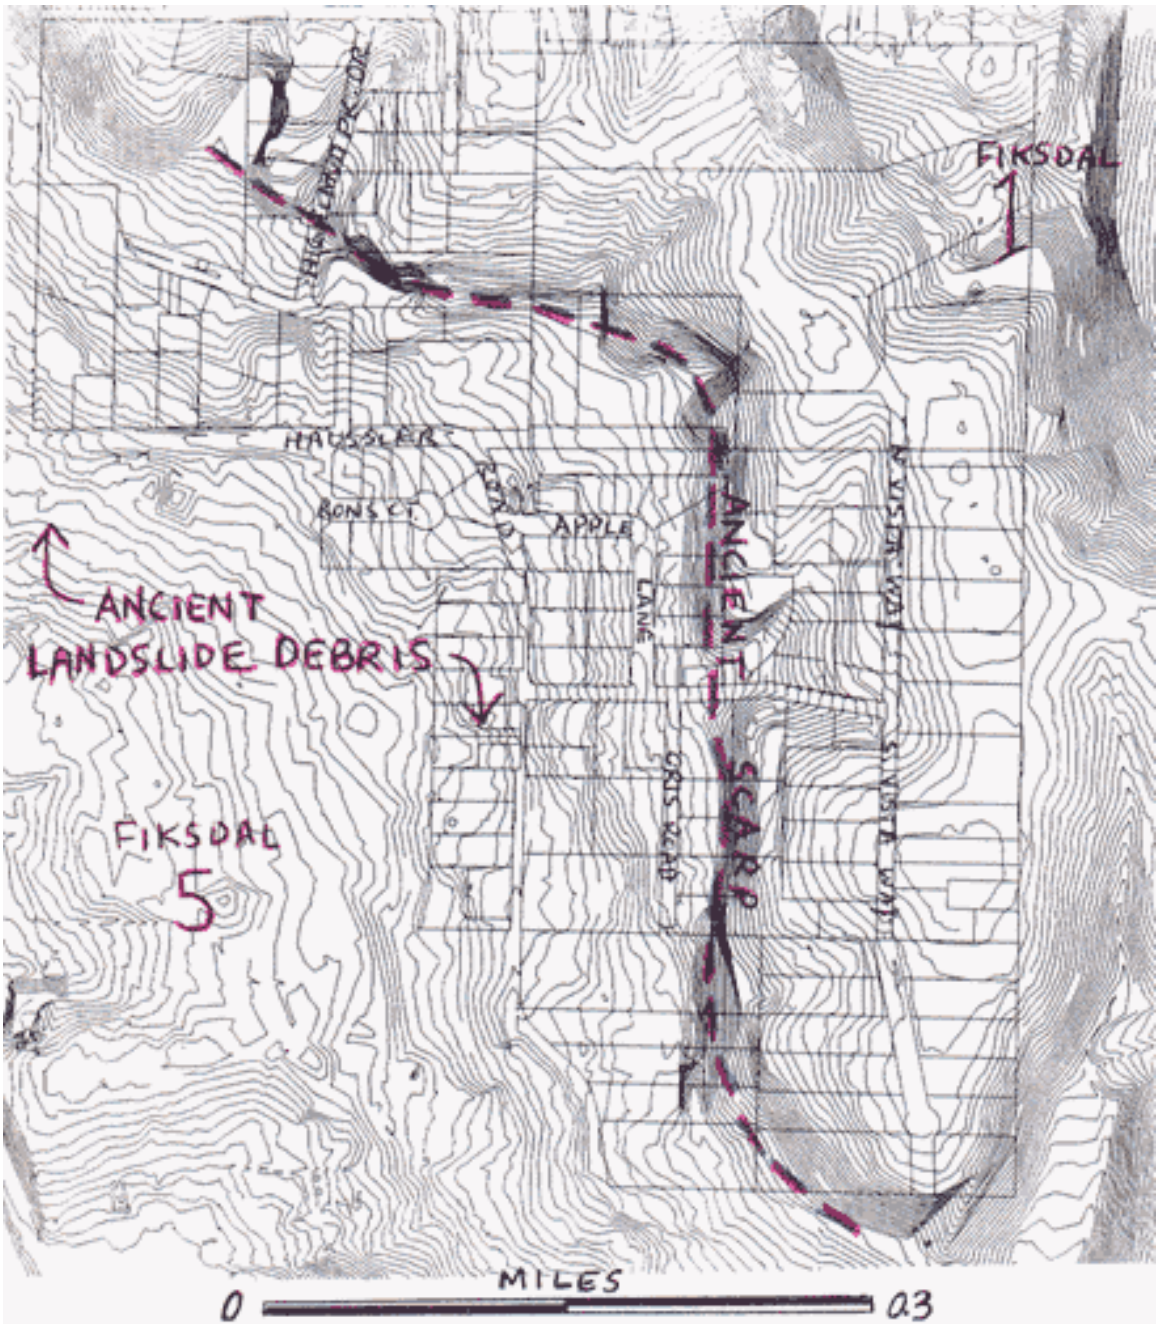
FIGURE 5

An initial site visit was conducted on January 18, 1999. Homes located at 494 Apple Lane and 131 South Vista Way were visited as these were known to be exhibiting signs of ground movement. At this time, it was noted that many homes in the neighborhood are built on an ancient landslide (Fiksdal, 1973). Therefore, the study area was selected to include all homes in the neighborhood, from the top of the ridge (North and South Vista Way) down to Rons Court (Figure 5). Note that the study area includes homes both above and below the scarp of the ancient landslide. The study area will herein be referred to as the Haussler Road area.

Ancient Landslide Boundaries, Haussler Road Area

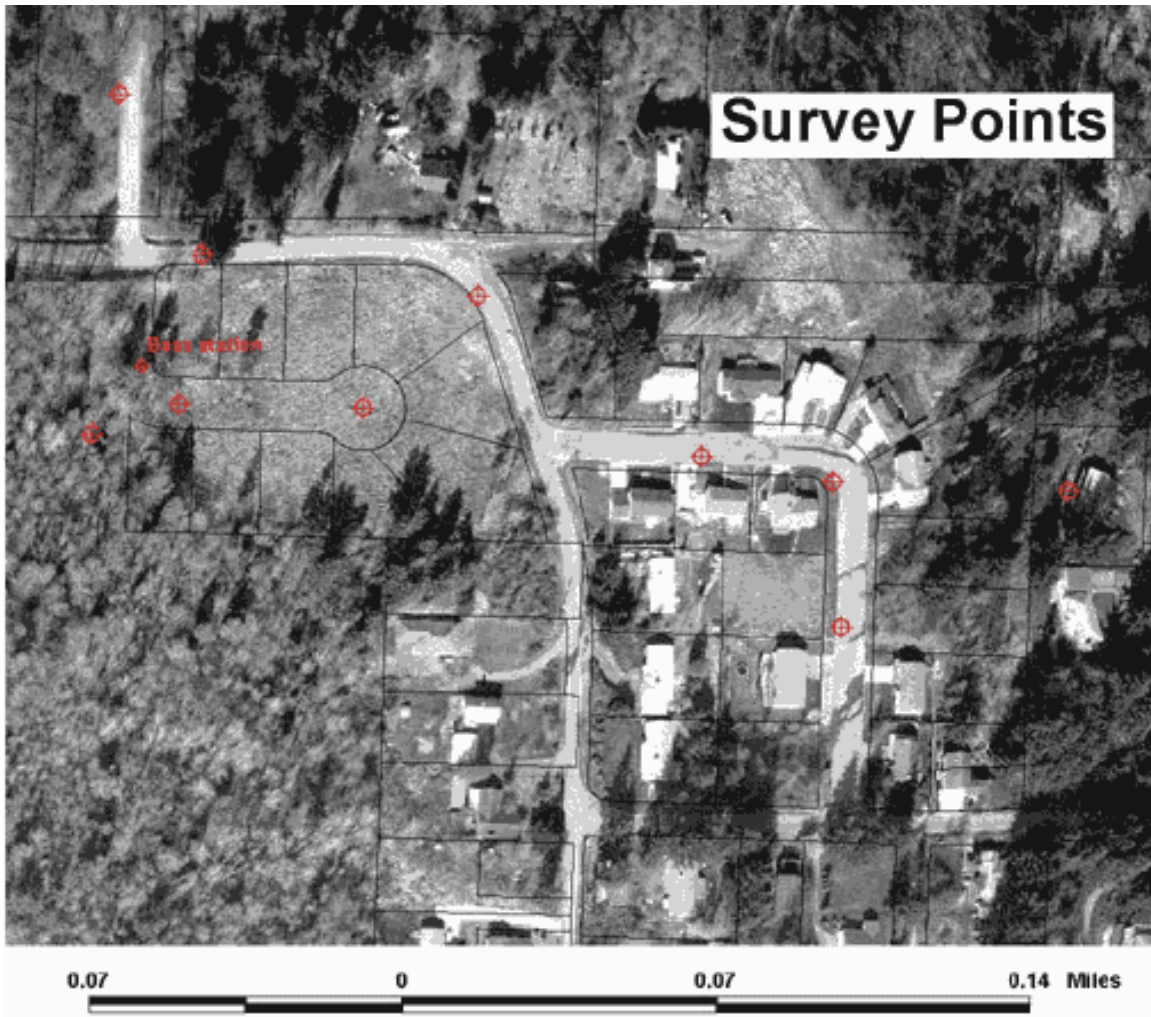
**FIGURE 6**  
**Station Locations - Ground Surface Survey**

On February 5, 1999, eleven sites (“stations”) on the ground surface in the Haussler Road area were selected for surveying (Figure 6). The station locations were selected in order to represent the ground surface both above and below the scarp of the ancient landslide. The station locations also had to be situated such that they would be visible from our survey equipment, a total station.

Because of the large size of the study area (approx 0.5 square mile), it was necessary to set up the total station (“base”) on Rons Court in order to have visual contact with as many stations as possible. This is problematic because the area around Rons Court is showing marked movement, and ideally the base in a survey should be stationary. However, since one station was located above the scarp and was assumed to not be moving, this was used as a control point. Figure 6 illustrates the location of these stations. Please note that station #2 is outside of the northern boundary of the photograph in Figure 6.

On March 2, 1999, reflectors were again set up at each station, at the same height above the ground. Station #4 could not be located as the road at that location had been repaved. This was due to the road being torn apart by slumping at that location. The station locations were surveyed, and northing, easting, and elevation were once again calculated. The coordinates calculated from each event are summarized in Table 1.

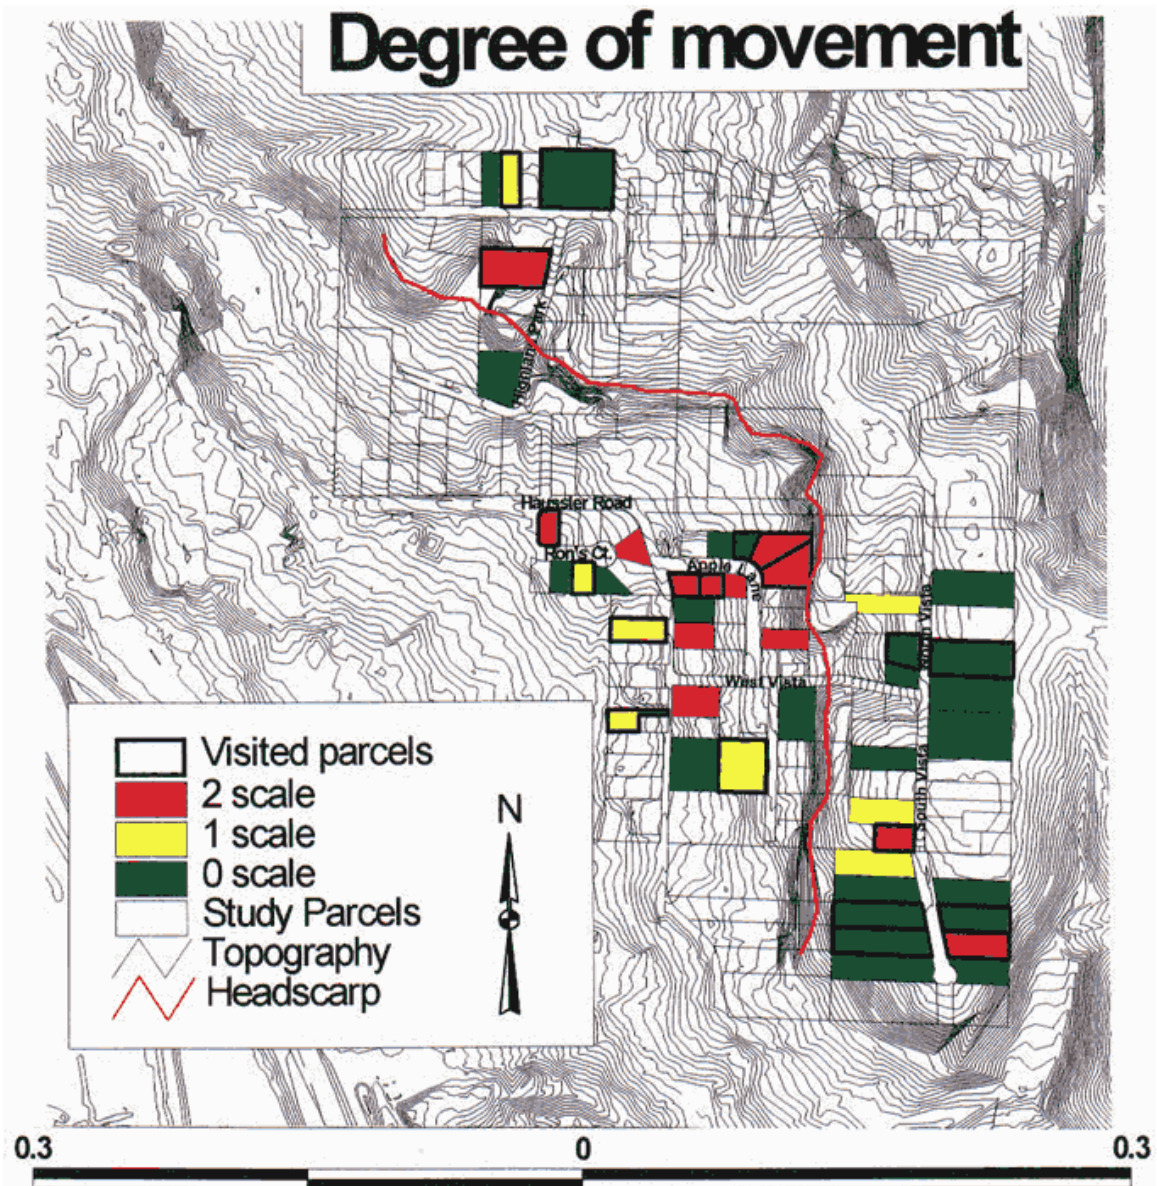
**FIGURE 7**  
**Results of Movement Evaluation**

The results of the overall code assignment are summarized in Table 2 and spatially presented on Figure 7. The property boundary for a home with a code of 2 is indicated in red, yellow for a 1, and green for a 0. As illustrated on Figure 5, 46% of all participating homes exhibited signs of movement. Of these, 66% are located below the scarp (on the ancient landslide), and 34% are located above the scarp. Movement in homes located above the scarp could possibly be undergoing localized movement associated with sliding on small, local drainage slopes of settling.

Based on the results of this study, it appears as though the ground is experiencing movement in the Haussler Road area in Kelso, Washington. In addition, a spatial pattern appears to exist among those homes exhibiting movement. A greater percentage of these homes are located on the ancient landslide than of those located above the landslide. Of the homes located above the ancient landslide scarp, 30% are exhibiting signs of movement. Of the homes located below the scarp (on the ancient landslide), 61% are exhibiting signs of movement.

Due to the subjective nature of the study, it is recommended that a more detailed study be conducted on the Haussler Road area as soon as possible. The detailed study will need to definitively determine if ground movement is occurring. In addition, the subsurface of the ancient landslide should be investigated to determine hydrology, slip plane location, and nature of the sediments and bedrock. The detailed study should utilize intrusive techniques such as slope inclinometer installation.
