**GROUND MOVEMENT STUDY
HAUSSLER ROAD AREA
KELSO, WASHINGTON**

Environmental Geology, G561
Portland State University
Winter Term 1999

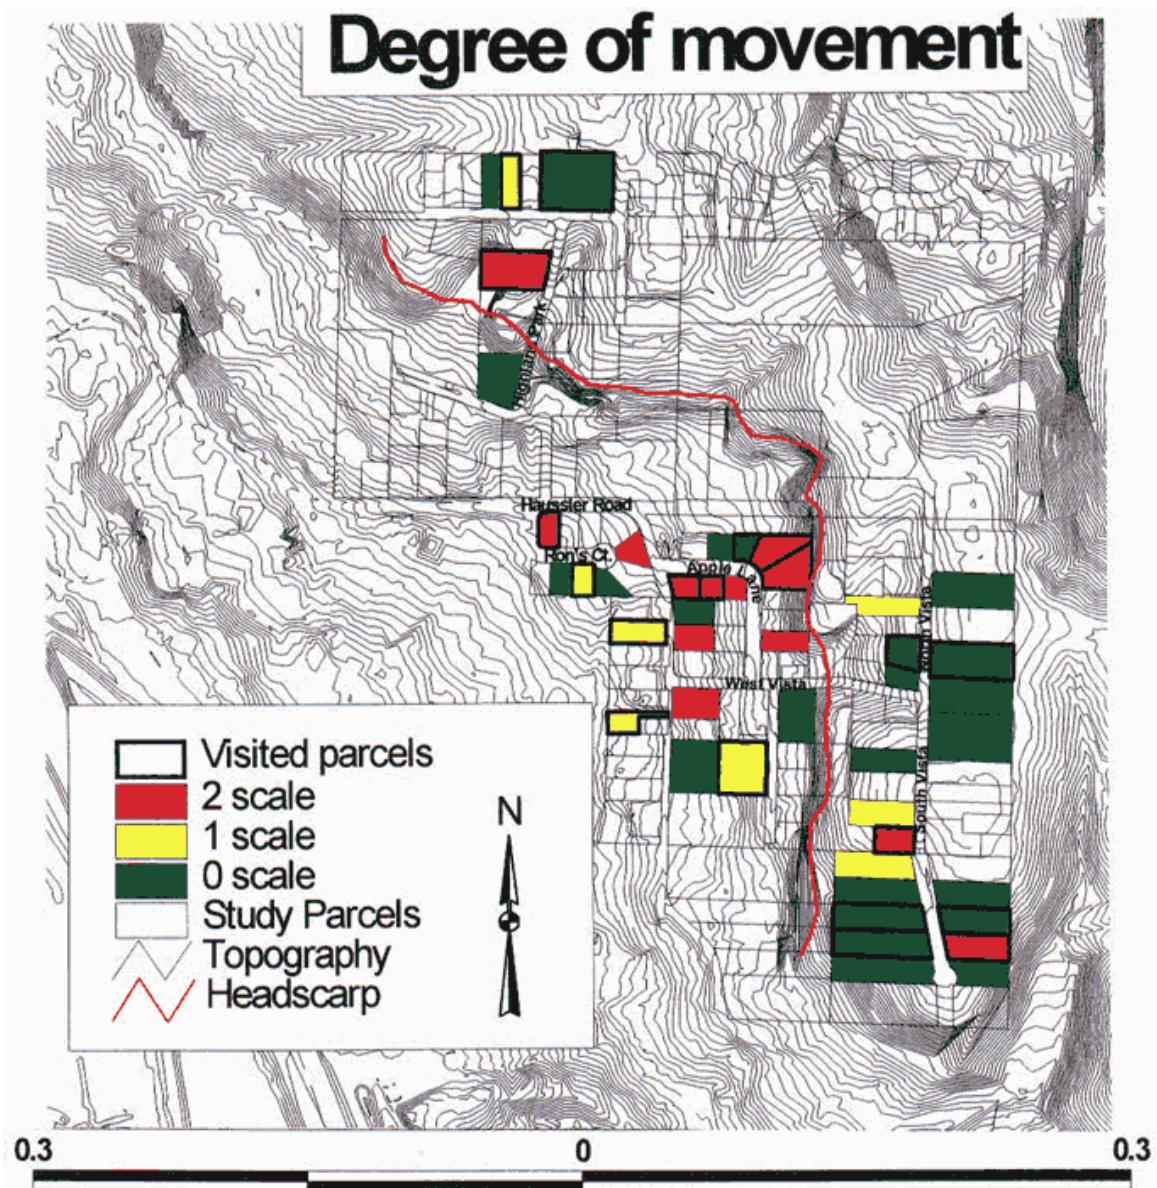
FIGURE 7
Results of Movement Evaluation

The results of the overall code assignment are summarized in Table 2 and spatially presented on Figure 7. The property boundary for a home with a code of 2 is indicated in red, yellow for a 1, and green for a 0. As illustrated on Figure 5, 46% of all participating homes exhibited signs of movement. Of these, 66% are located below the scarp (on the ancient landslide), and 34% are located above the scarp. Movement in homes located above the scarp could possibly be undergoing localized movement associated with sliding on small, local drainage slopes of settling.

Due to the subjective nature of the study, it is recommended that a more detailed study be conducted on the Haussler Road area as soon as possible. The detailed study will need to definitively determine if ground movement is occurring. In addition, the subsurface of the ancient landslide should be investigated to determine hydrology, slip plane location, and nature of the sediments and bedrock. The detailed study should utilize intrusive techniques such as slope inclinometer installation.
